## **GARAGE DOOR SAFETY INCIDENTS.**

**This newsletter lists a number of garage door safety incidents to highlight what can go wrong and what can be learnt from those incidents.**

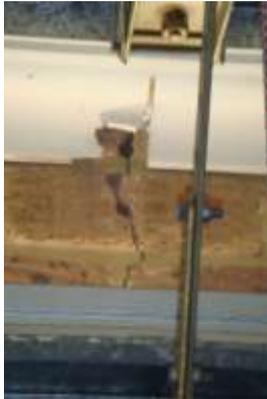
- The screws were considerably smaller than those recommended in the manufacturer's instructions
- The undersized screws had been 'worked' by the door operation over 5 years and in combination with cracking

failure of the bricks, caused the screw fasteners to fail.

- The force of the stored energy in the spring made the spring assembly strike the door damaging it.

VIEW OF THE SPRING ASSEMBLY  
AFTER STRIKING DOOR

VIEW OF CRACKED BRICKWORK

- all fixings (including screws) should be installed

as per manufacturer's specifications which in relation to screws such specifications can be a specific type and dimension of screw or by specifying the design force they are required to satisfy.
